RE: Category N Baseline Environmental Assessment
Former Power Station and Copper Ore Processing Facility
Lake Linden (Torch Lake Township), Michigan

DISCLOSURE OF A BASELINE ENVIRONMENTAL ASSESSMENT
(FORM EQP4446(REV.3/99))

REGIONAL LOCATION MAP
BASELINE ENVIRONMENTAL ASSESSMENT
FORMER POWER STATION AND
COPPER ORE PROCESSING FACILITIES
TORCH LAKE TOWNSHIP
HOUGHTON COUNTY, MICHIGAN

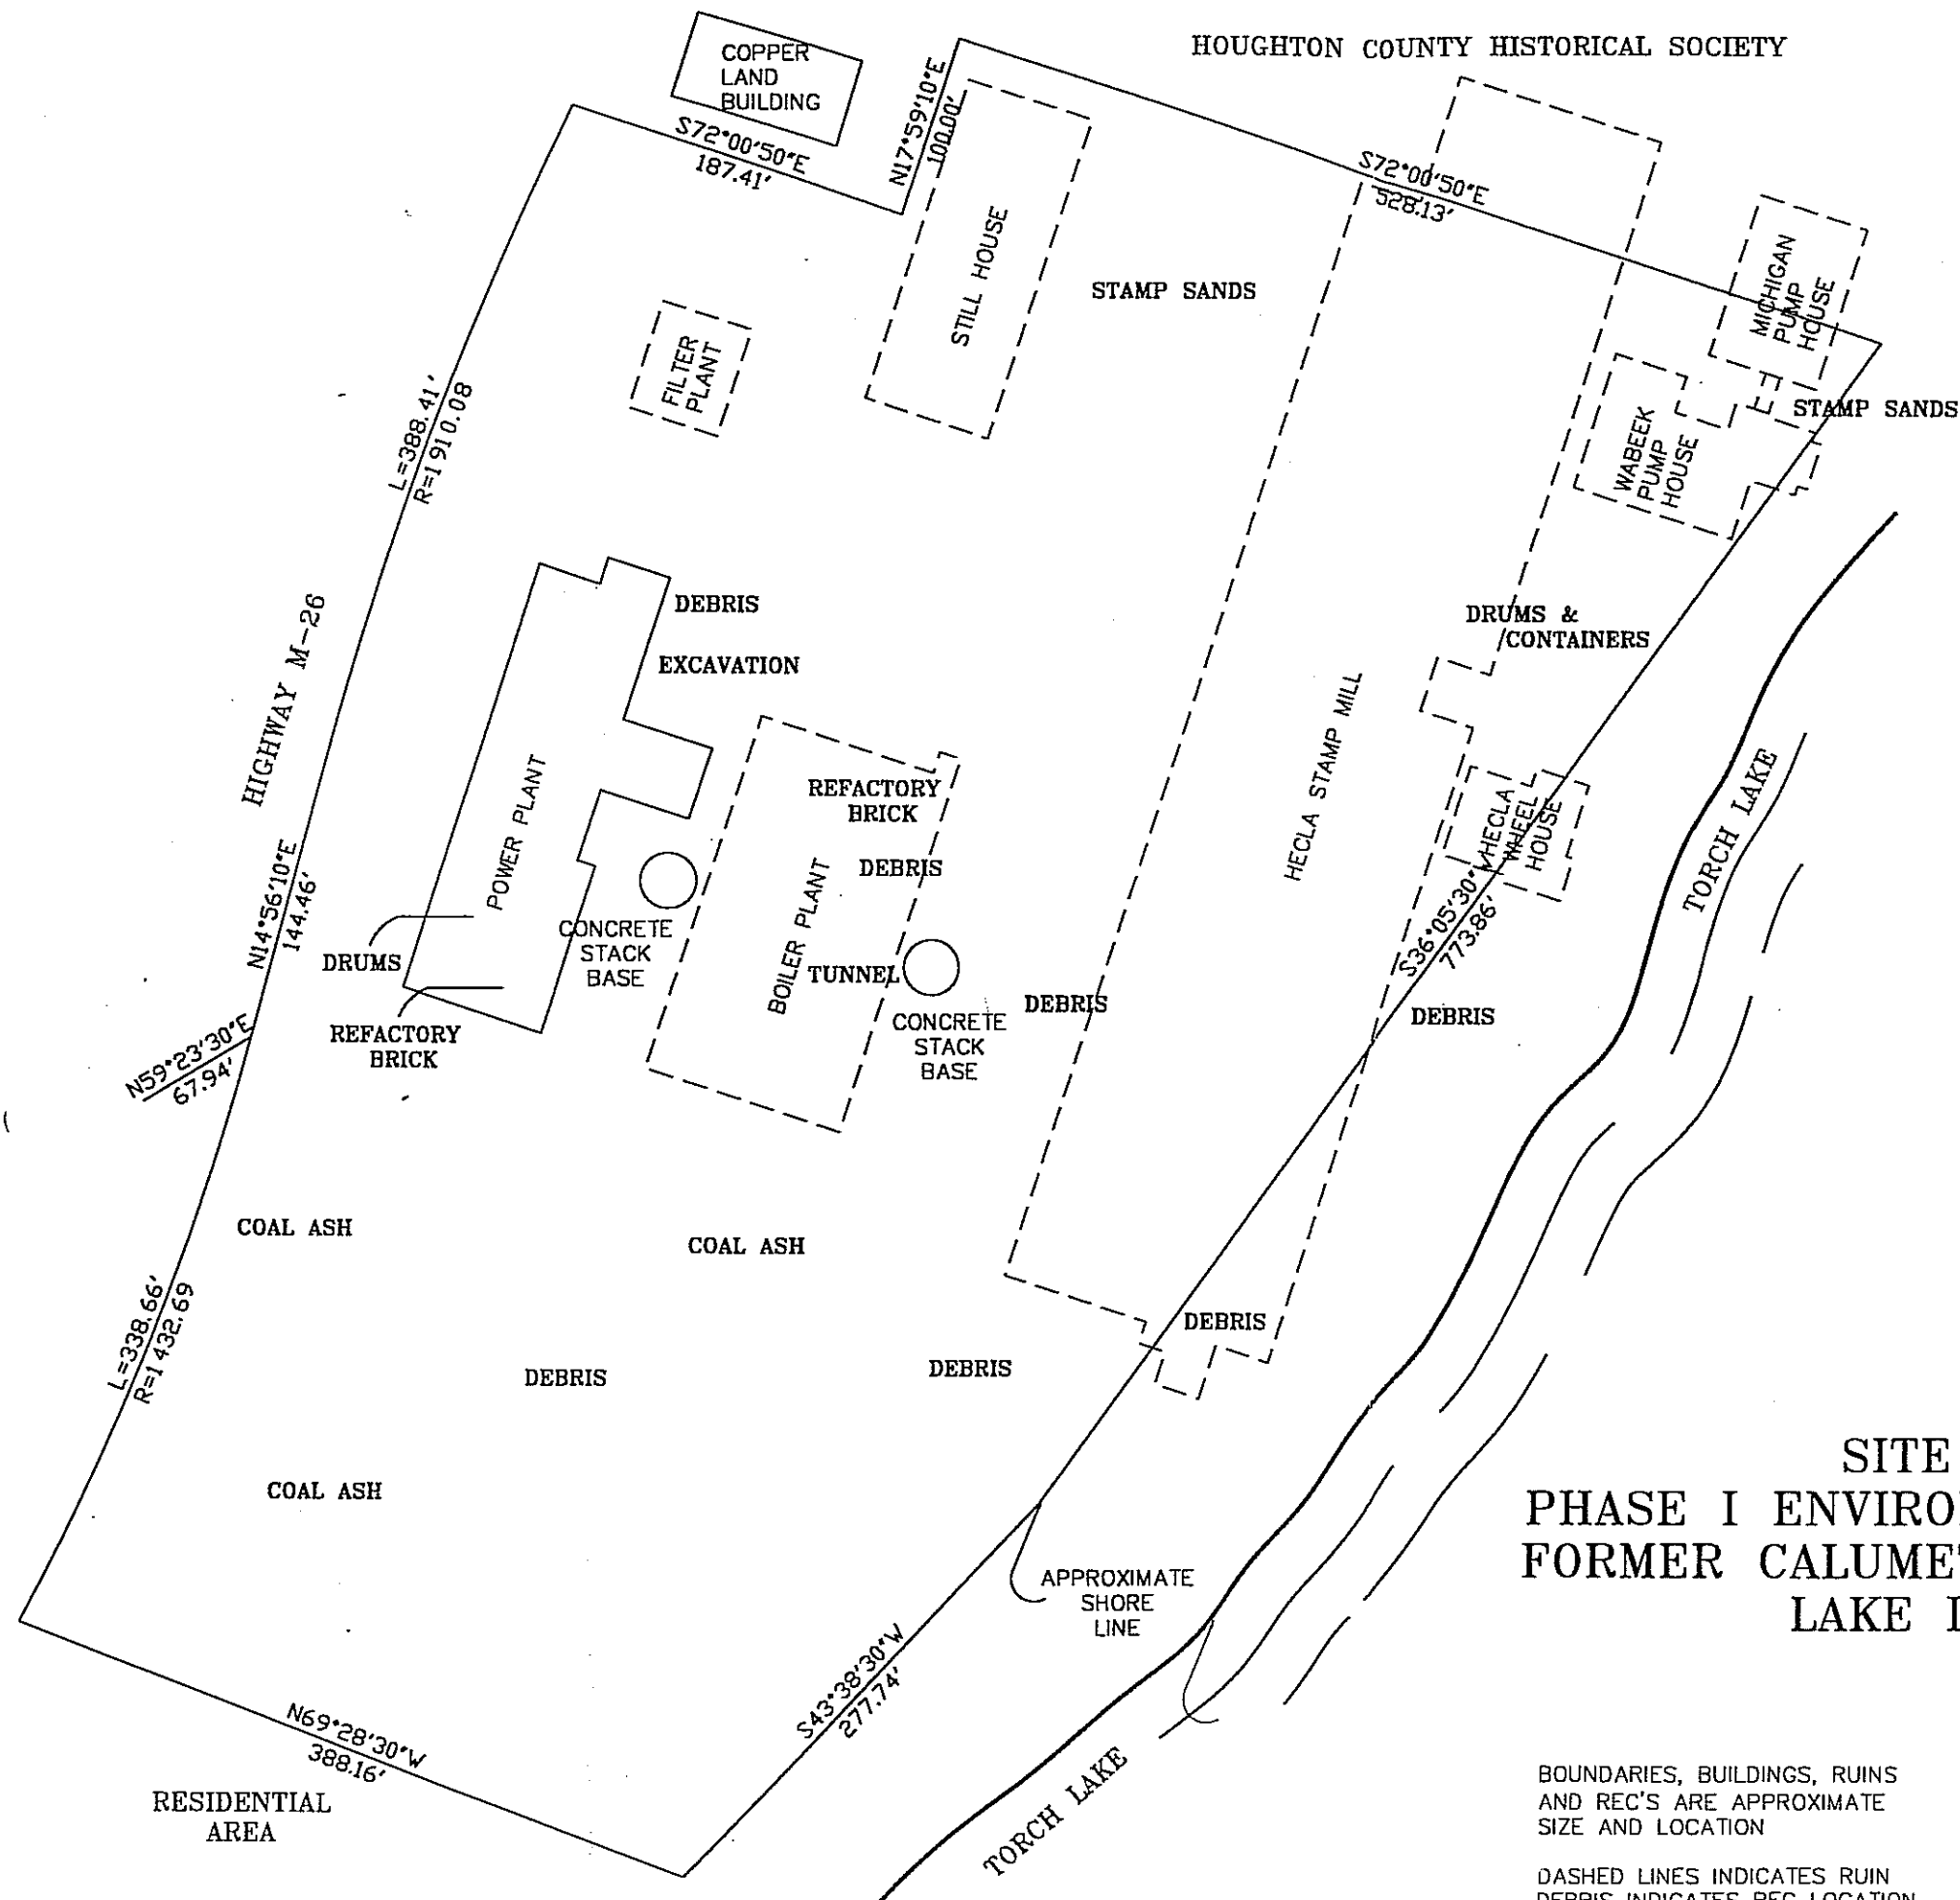
SITE FEATURES MAP
PHASE I ENVIRONMENTAL SITE ASSESSMENT
FORMER CALUMET & HECLA POWER STATION
LAKE LINDEN, MICHIGAN
FIGURE 4

BOUNDARIES, BUILDINGS, RUINS
AND REC'S ARE APPROXIMATE
SIZE AND LOCATION
